State of California
Department of Public Works
Division of Highways
Materials and Research Department

January 1963

FRESNO STATE COLLEGE
SPEECH DRAMA AUDITORIUM
NOISE REDUCTION SURVEY

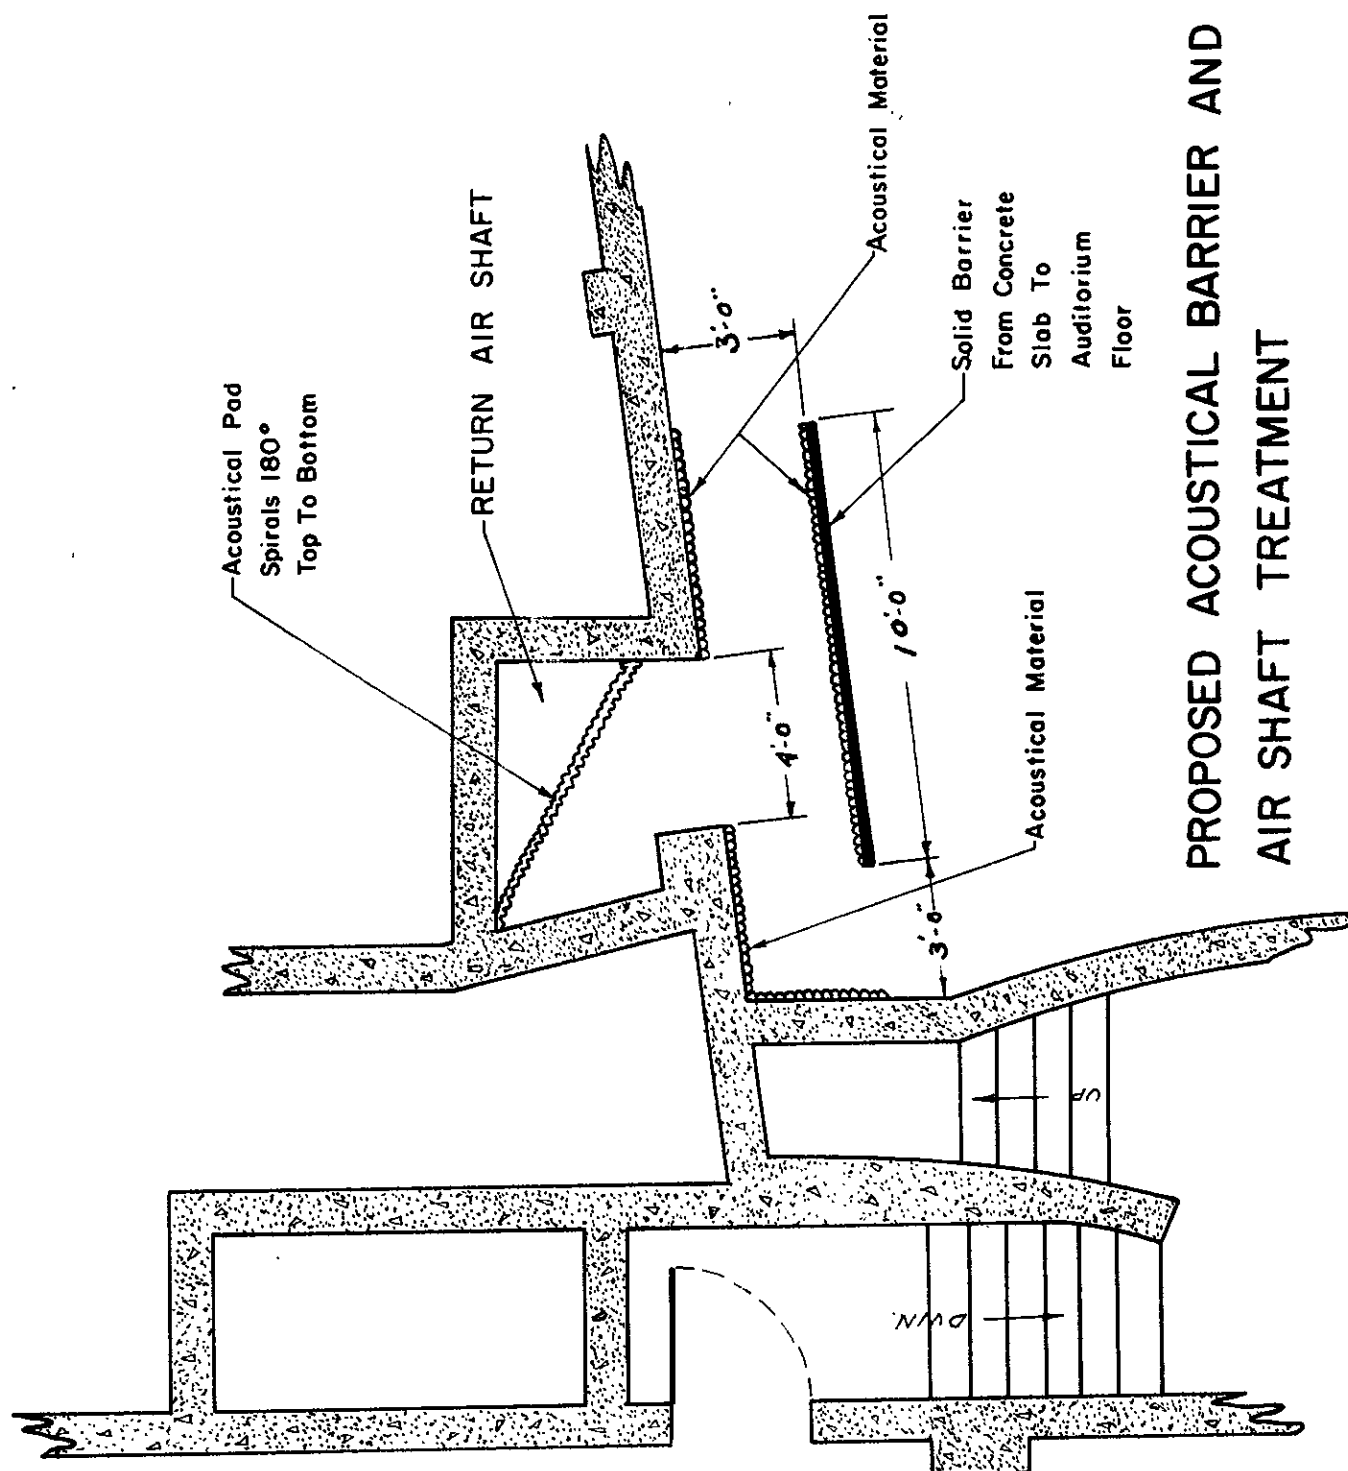
Figure 1

PROPOSED ACOUSTICAL BARRIER AND AIR SHAFT TREATMENT

(Portion of basement plan taken from sheet 4 of file 8-K-27)

1. The three air vents located in the roof, directly over the stage, should be equipped with sound traps to reduce the penetration of aircraft noise.
2. (A) The vertical return air shaft (which runs from under the auditorium floor to Fan and Mechanical Room 206) should have an acoustical pad installed in the manner of a slow spiral, with a 180 degree turn from top (just below fan opening) to bottom (just above the port opening below the auditorium floor). The pad should begin diagonally across the longest horizontal dimension of the shaft (corner to corner) and be securely attached to the walls as it descends.

(B) A 10 foot long solid barrier should be placed 3 feet away from the lower port opening, between auditorium floor and the concrete slab. The barrier surface facing the port, and the adjacent wall surfaces, should be covered with a one inch thickness of glass fiber duct-liner or an equally absorbent acoustical material of your choice. Please refer to Figure #1.

An acoustical pad, suitable for the described installation in the return air shaft, can be made from a one inch thickness of duct-liner placed between outer covers of asbestos cloth, the whole to be quilted together and seamed at the edges to prevent ravelling. Care will be required so as not to tear the cover during installation.

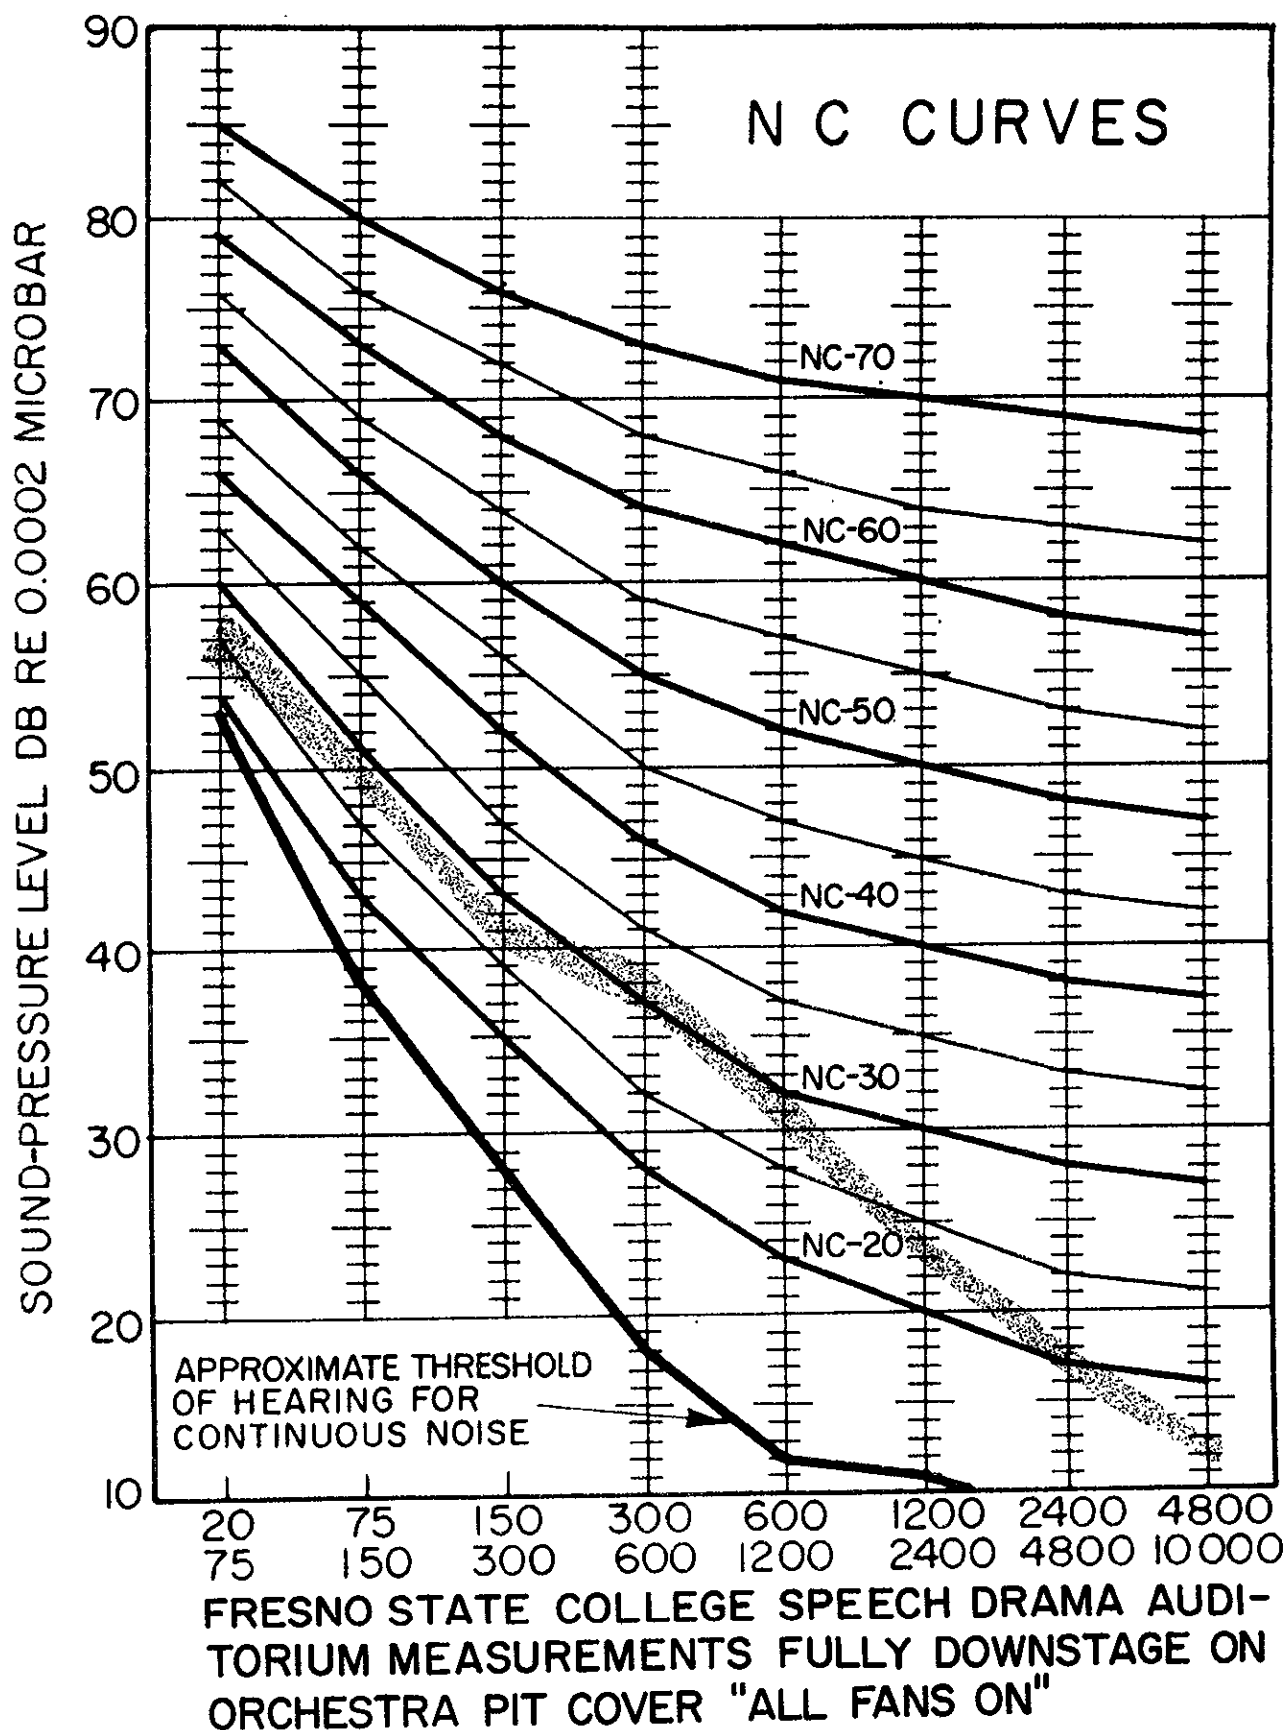
The principal internal noise source was determined to be from exhaust fan E-1. Figure 2 is an octave band portrayal of total equipment noise on an NC chart.

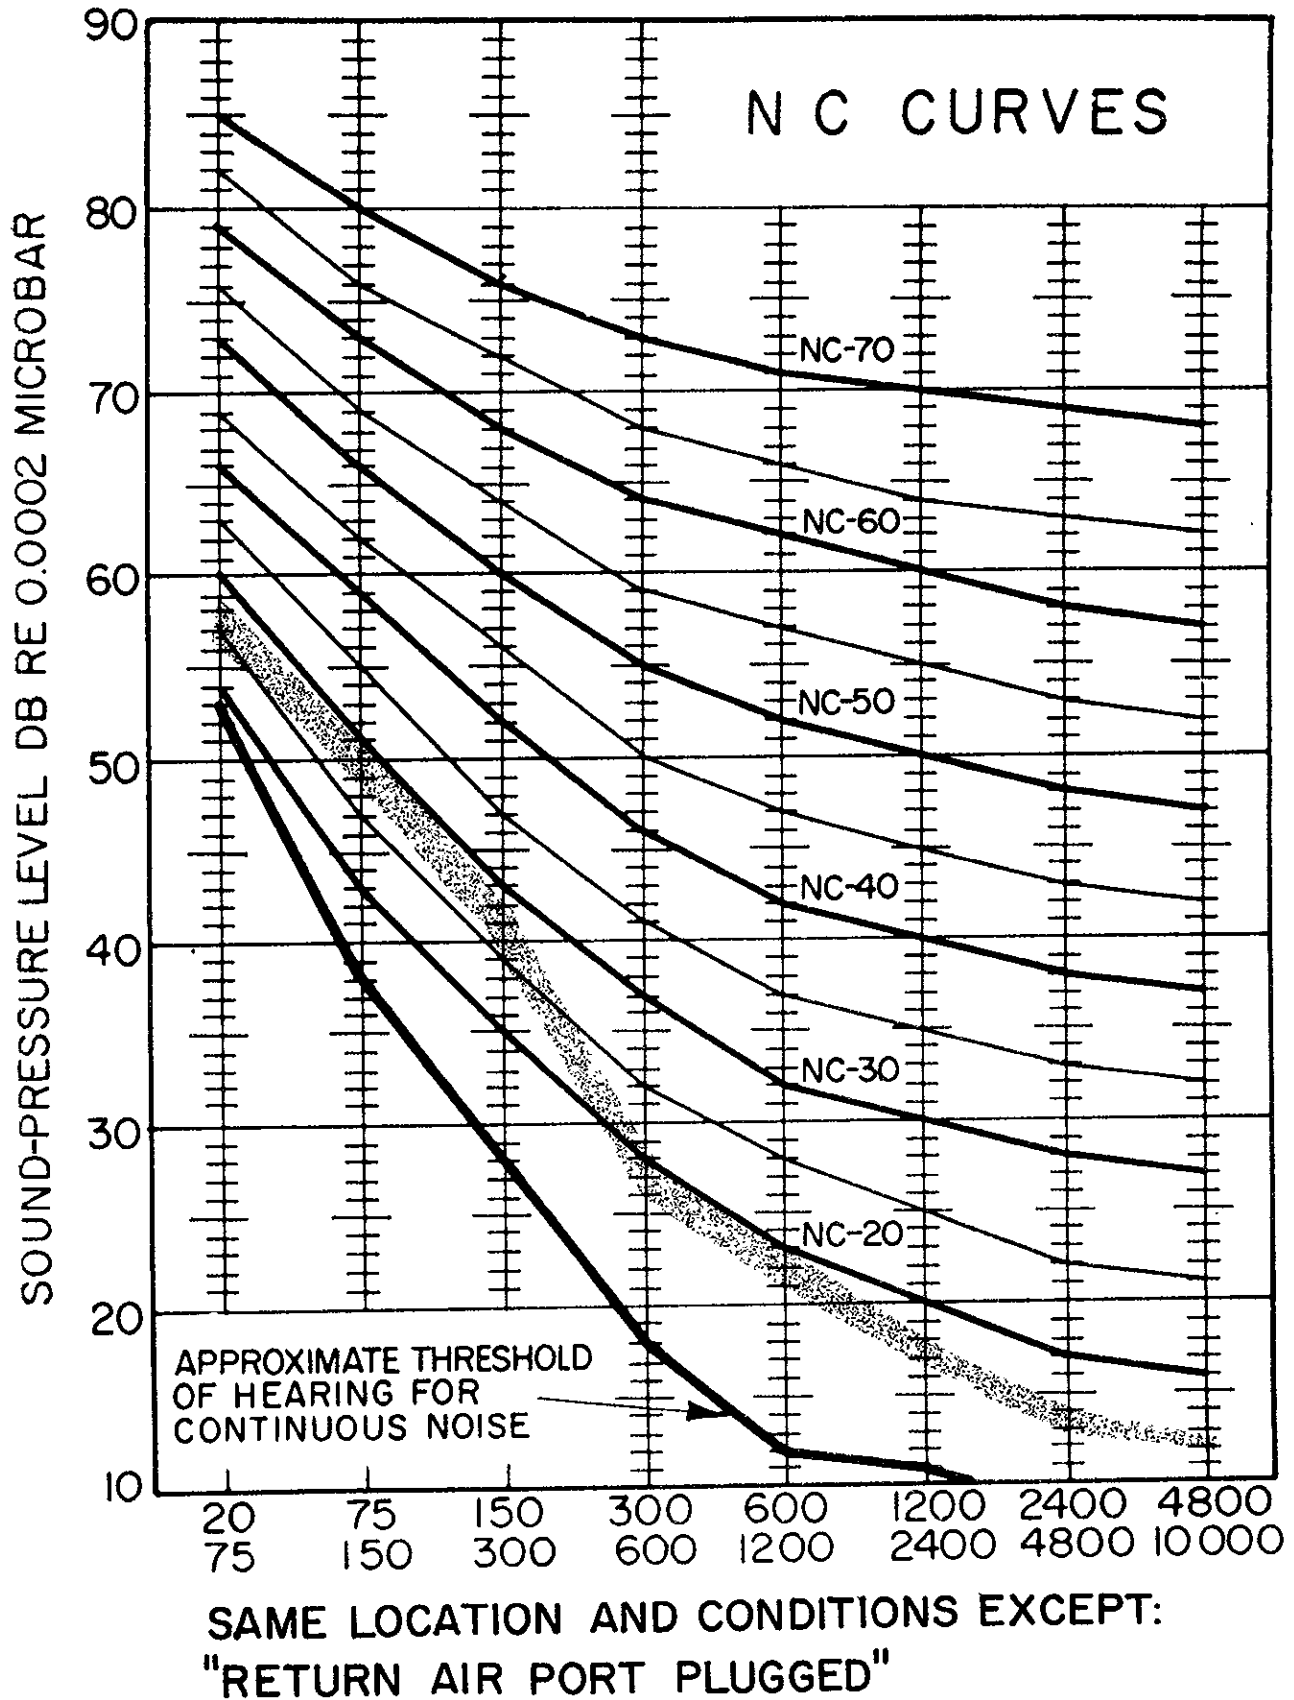
Figure 3 shows a marked noise reduction in the speech interference range, octaves 4, 5, and 6, achieved by temporarily plugging the return air port with a heavy plywood cover. This is a reasonable approximation of what can be accomplished by absorptive treatment in the shaft plus the acoustic barrier already described.

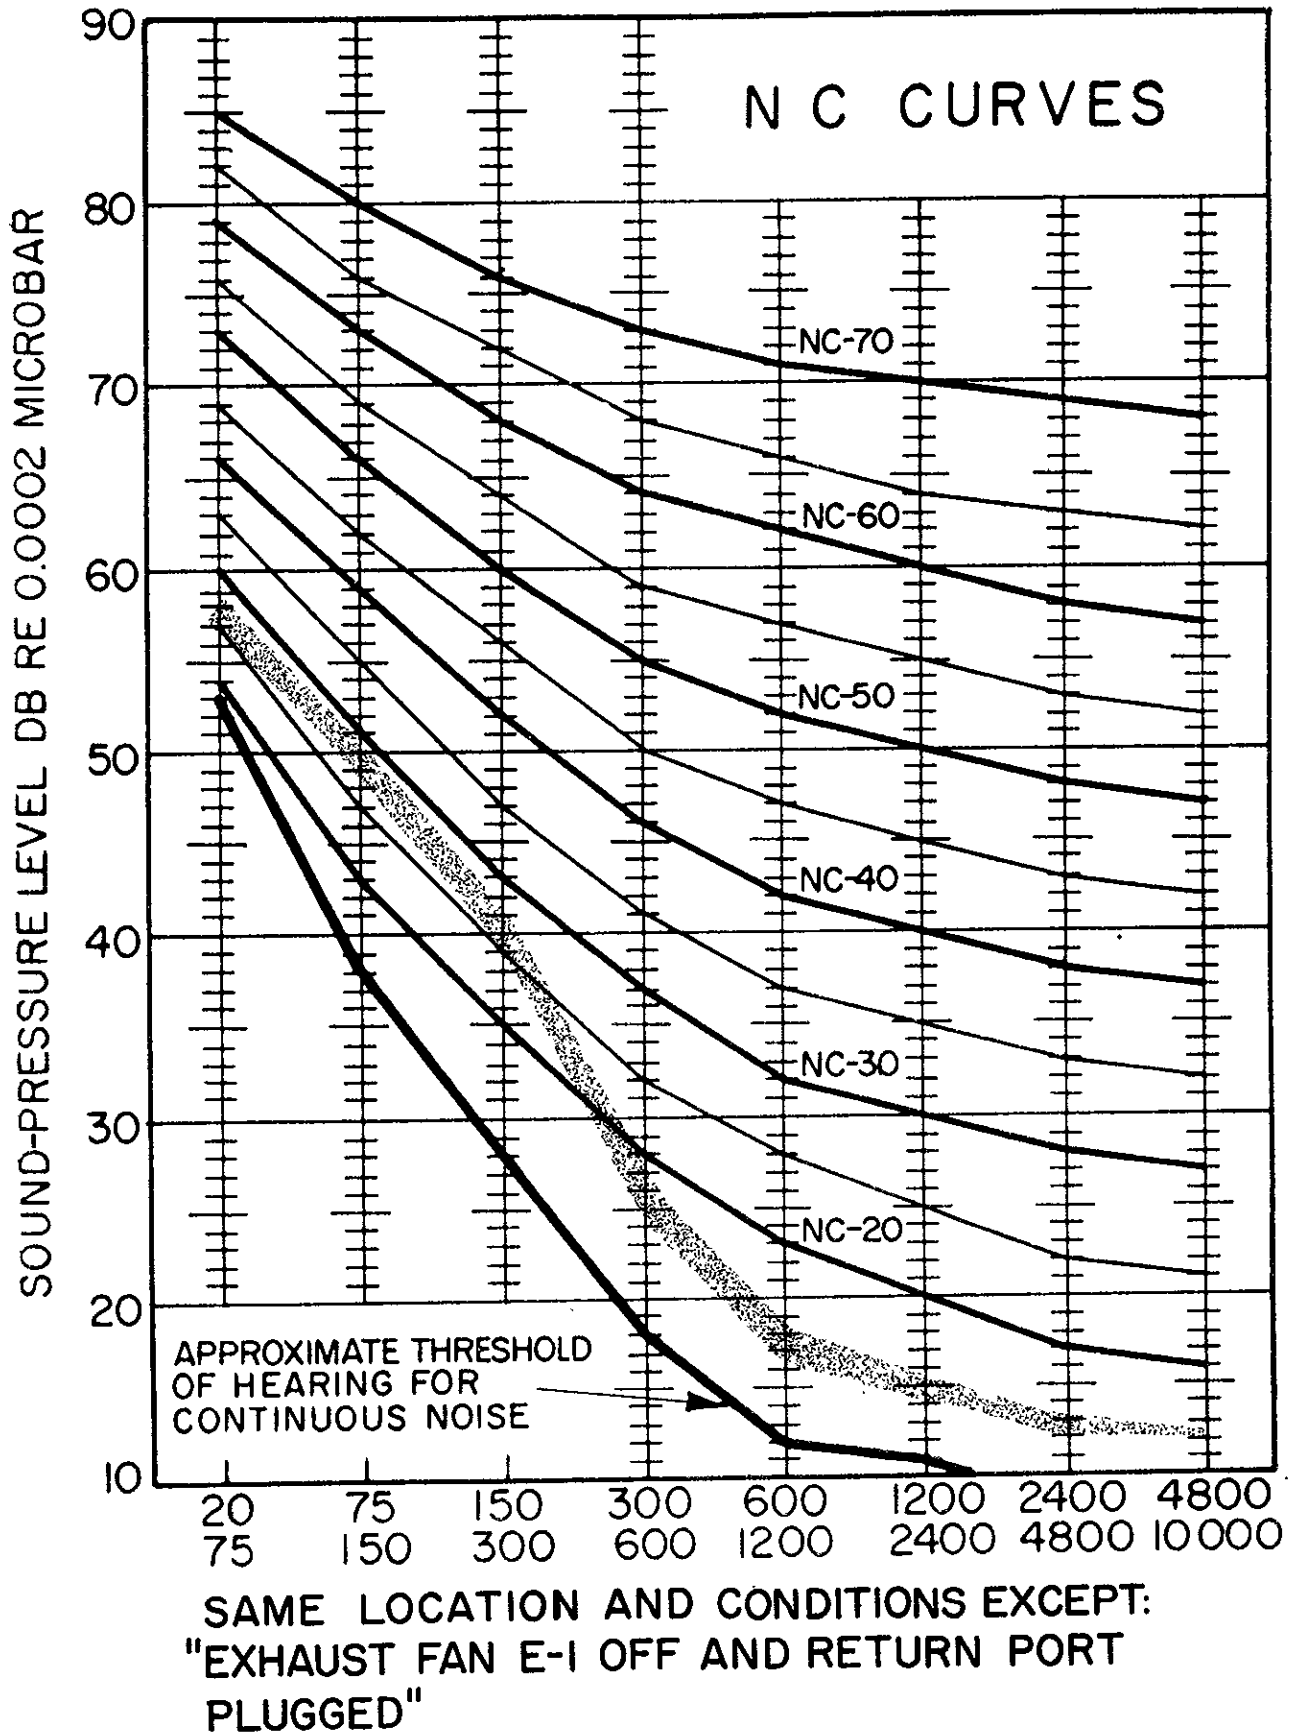
Figure 4 illustrates an additional improvement in the speech interference range, by turning off fan E-1. This is a reasonable approximation of the additional improvement that can be realized if the present rubber mountings on fan E-1 are changed to a more effective spring suspension type, providing the air shaft treatment and acoustic barrier are first installed.

3. The return air fan E-1 should be equipped with spring type vibration isolating mounts. The present rubber mounts are not adequate to prevent noise conduction.
